Subject:
Code 17090

Unit:
01J CVT

Vehicle Applications:
Audi A4

01J CVT: Diagnosing and Repairing Code 17090

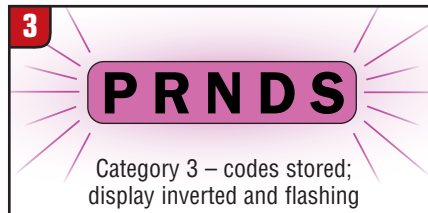
Non-critical with restrictions

with some restrictions, and the TCM informs the driver by inverting the display of the gear-selector-position indicator (Figure 2).

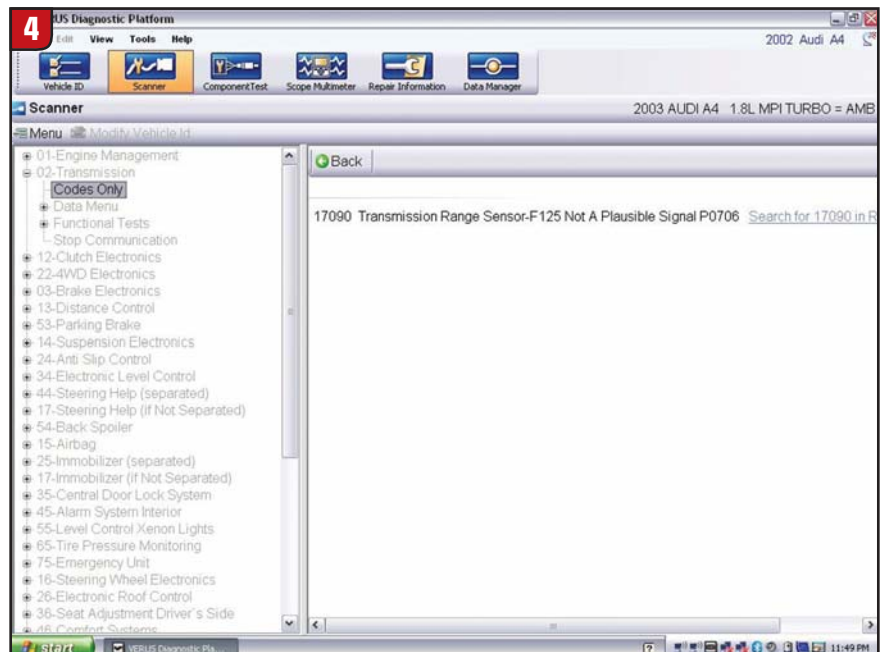
When we scanned the vehicle for codes, we obtained code 17090 “Transmission Range Sensor (F125)” (Figure 4), but since the

malfunction was intermittent we could not detect the problem of which the customer was complaining.

After a couple of road tests the problem the customer had complained of appeared and the gear-selector-indicator lights were inverted and flashing, telling us there was a critical-state code.

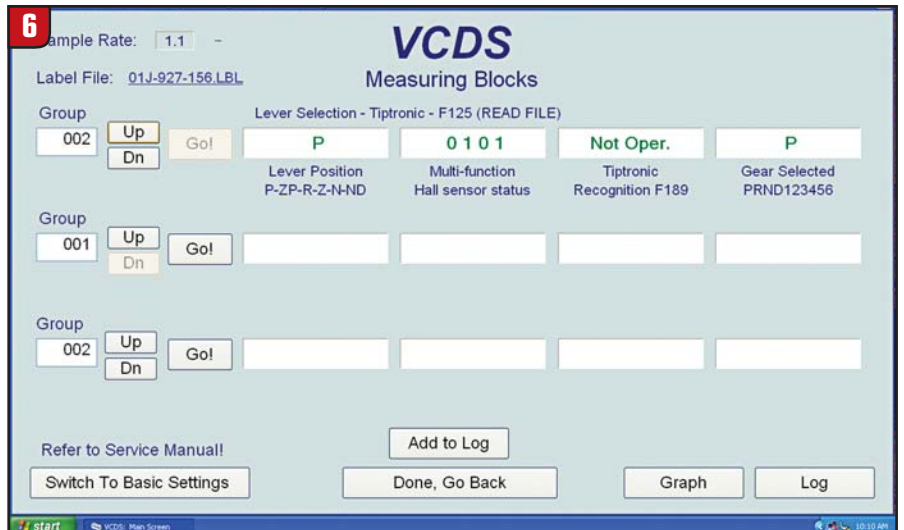
5 Gear-selector-lever position	Hall-effect sensor states			
	A	B	C	D
P	0	1	0	1
Between P & R	0	1	0	0
R	0	1	1	0
Between R & N	0	0	1	0
N	0	0	1	1
Between N & D	0	0	1	0
D	1	0	1	0
Faulty logic combinations	0	0	0	0
	0	0	0	1
	0	1	1	1
	1	0	0	0
	1	0	0	1
	1	0	1	1
	1	1	0	0
	1	1	0	1
	1	1	1	0
	1	1	1	1

The transmission multi-function range sensor (F125) provides a logic state that informs the TCM of the gear selected. The sensor is composed of four Hall-effect sensors that are controlled by the magnetic gate on the selector shaft and can produce both high and low voltage readings. A high voltage reading means the switch is closed and is given a value of "1." A low voltage reading means the switch is open and is given a value of "0." Thus, a Hall-effect sensor can generate two signals: 1 and 0. These four sensors can produce 16 different gearshift combinations: four for the gear selected (P, R, N and D); two for intermediate positions (P-R and R-N-D); and 10 combinations that are considered faulty (Figure 5). One thing worth mentioning here: If Hall-effect sensor D fails,
