Subject:
Code 17090

Unit:
01J CVT

Vehicle Applications:
Audi A4

01J CVT: Diagnosing and Repairing Code 17090

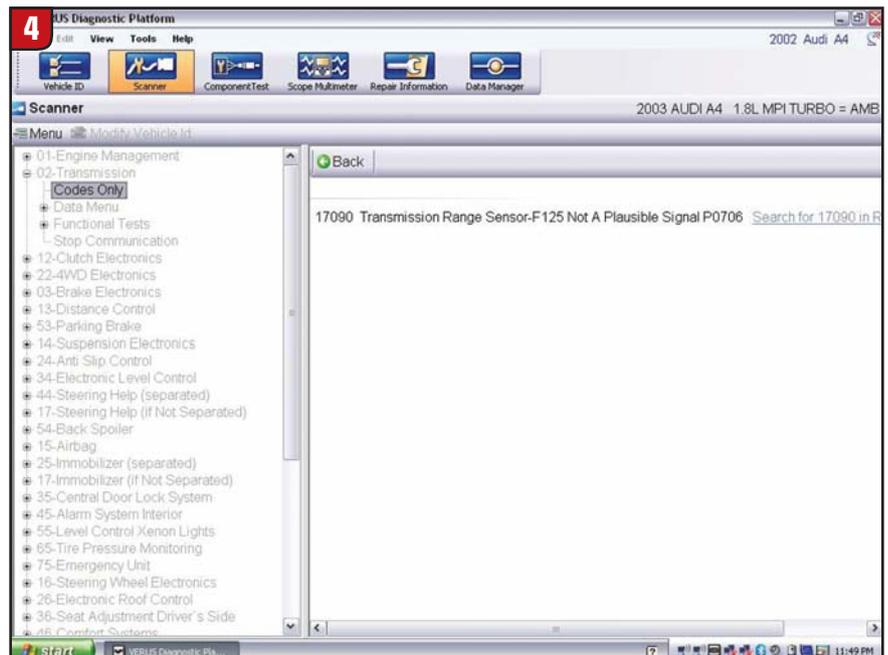
Category 1 – codes stored; no display change

Non-critical state

Category 2 – codes stored; display inverted

Non-critical with restrictions

Category 3 – codes stored; display inverted and flashing

Critical state and failsafe

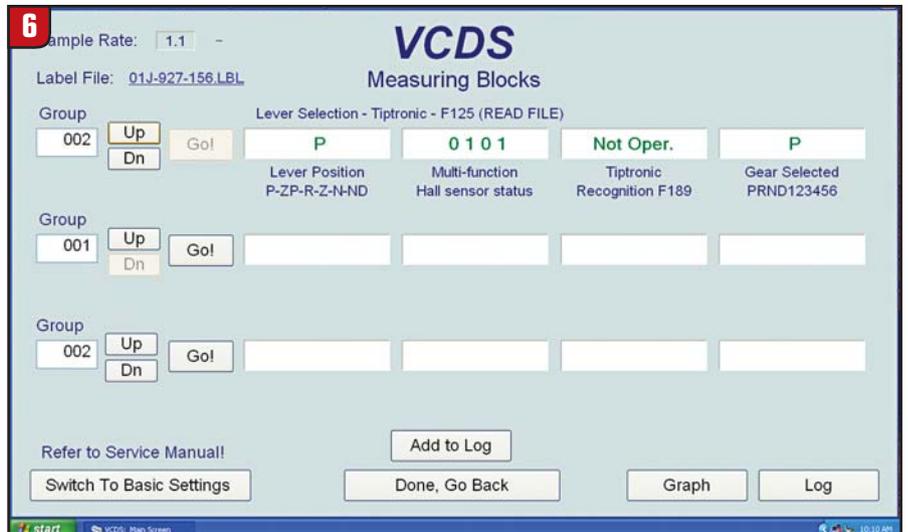
Using a scan tool to see the status of the multi-function sensor

By using the data parameters (see example in Figure 6) we checked the logic state of the transmission range sensor and found it to be in the fault state.

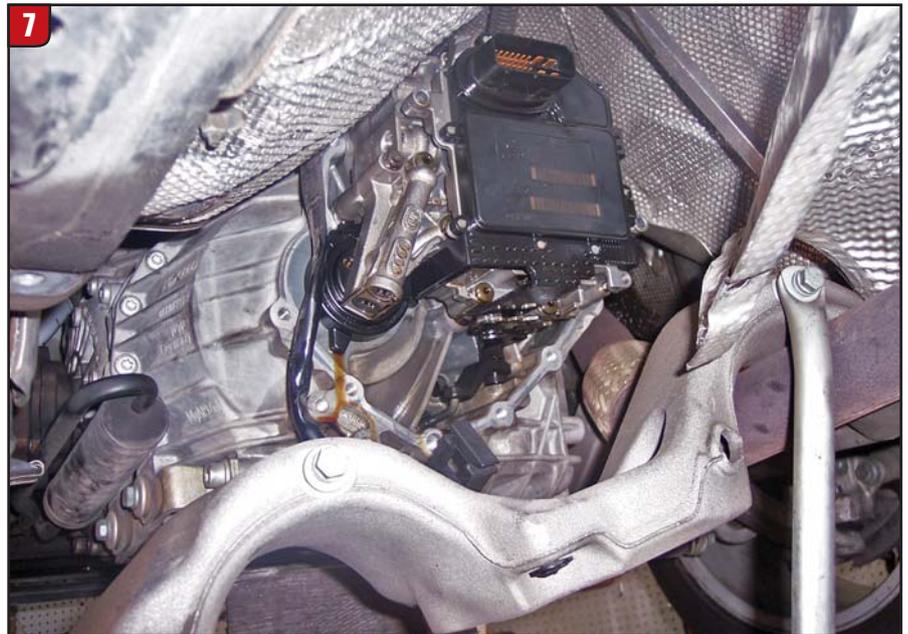
The TCM is fastened to the valve body with three bolts.

Since the range sensor is part of the TCM, we had to remove the TCM from the valve body (Figure 7).

So we sent the vehicle's TCM to BBA-REMAN to have it rebuilt, and it took only four days round trip. By going to the company's Web site, www.bba-reman.com, we were able to handle everything on-line, including printing a UPS call tag. One piece of advice here: Once you are on the Web site, make sure you click on the right flag for the country you are in. You also can accomplish the transaction by phone.

When we received the rebuilt TCM we installed it and replaced the seal, gasket and rear-cover bolts. According to Audi these are stretch bolts that are made to be used only once.

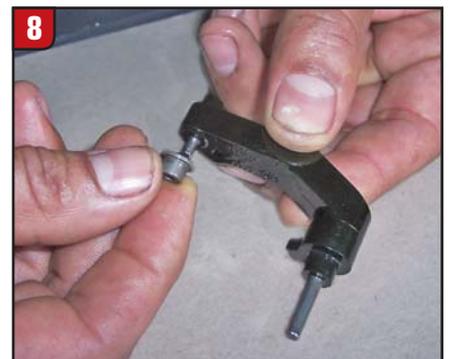
When you remove the spring tension from the detent and remove it from the selector shaft, be careful not to lose the small wheel in it, as it can fall off easily.

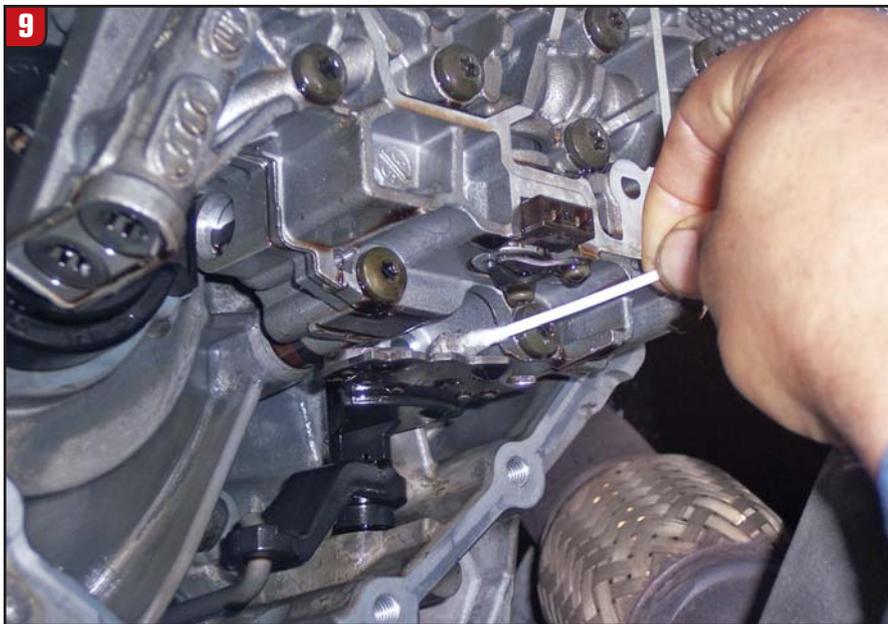
Checking for metal particles on the selector-shaft magnetic gate

When we removed the TCM we checked for metal particles on the selector-shaft magnetic gate (Figure 9). These metal particles can cause false readings by exciting the Hall-effect sensors; however, we did not find any indication of that on this vehicle, so the problem had to be inside the TCM.
