Subject:
Code 17090

Unit:
01J CVT

Vehicle Applications:
Audi A4

01J CVT: Diagnosing and Repairing Code 17090

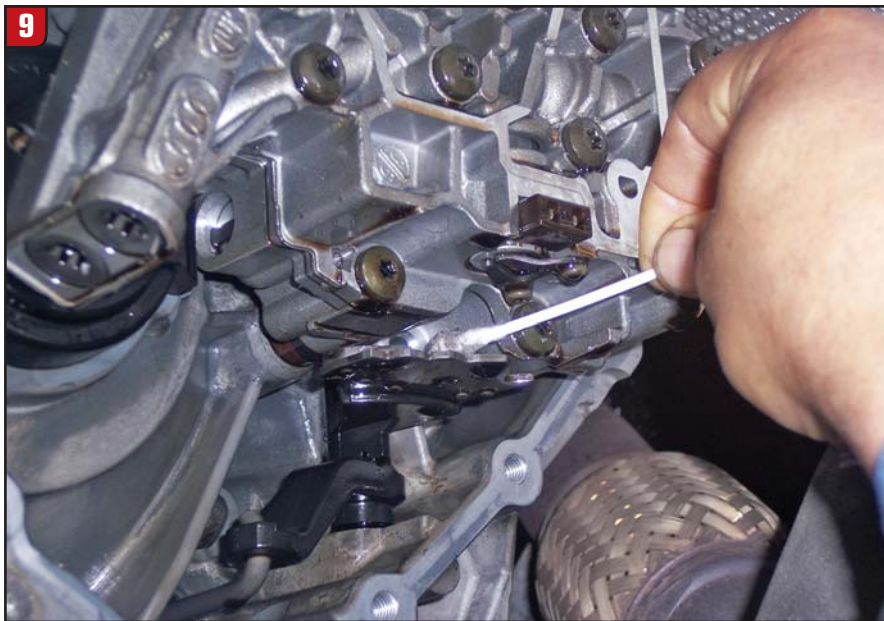
9 Checking for metal particles on the selector-shaft magnetic gate

When we removed the TCM we checked for metal particles on the selector-shaft magnetic gate (Figure 9). These metal particles can cause false readings by exciting the Hall-effect sensors; however, we did not find any indication of that on this vehicle, so the problem had to be inside the TCM.

When we received the rebuilt TCM we installed it and replaced the seal, gasket and rear-cover bolts. According to Audi these are stretch bolts that are made to be used only once.
